# Operating Experience Weekly Summary 97-23

*May 30 through June 5, 1997*

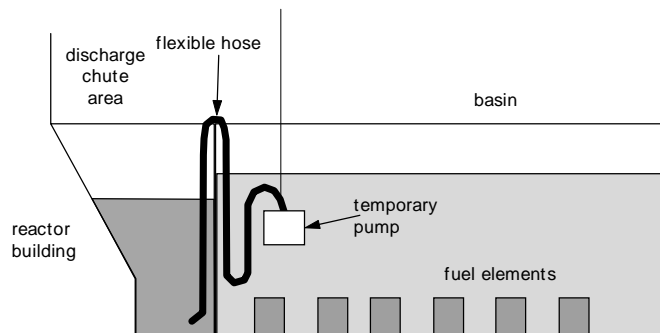
### Figure 2-1. Side View of the Temporary Pump Configuration

On May 29, 1997, at the Hanford K-Basins West, facility managers declared an Unreviewed Safety Question (USQ) discovery because a temporary pump and flexible hose could siphon water out of the basin after a postulated design basis earthquake. Workers immediately removed the hose and eliminated the siphon potential. A subsequent engineering analysis revealed that K-Basins had been in a USQ condition for approximately 2 years. Investigators determined that the work controls and safety evaluation for the temporary pump installation were inadequate. Failure to provide appropriate work controls for the temporary modification resulted in the USQ and lowered the margin of safety. (ORPS Report RL--PHMC-KBASINS-1997-0008)

Investigators determined that the pump was originally installed in May 1995. Maintenance workers installed the pump to circulate water from the basin into the discharge chute area to maintain water clarity (see figure 2-1). In May 1997, engineers determined that in the event of a design basis earthquake, the pump could detach from its support and fall to the bottom of the basin. They also determined that if the pump was operating before a postulated design basis earthquake and the flexible hose broke off, it could create a siphon condition that would transfer water out of the basin. This type of accident had not been analyzed.

Investigators determined that maintenance workers originally installed the pump using a routine work request that was inappropriate for this type of temporary modification because the safety evaluation was inadequate for proposed work. The installation should have been performed using a temporary modification package. Facility personnel are evaluating the work controls program to determine when routine work requests are appropriate and when temporary modification packages should be used.

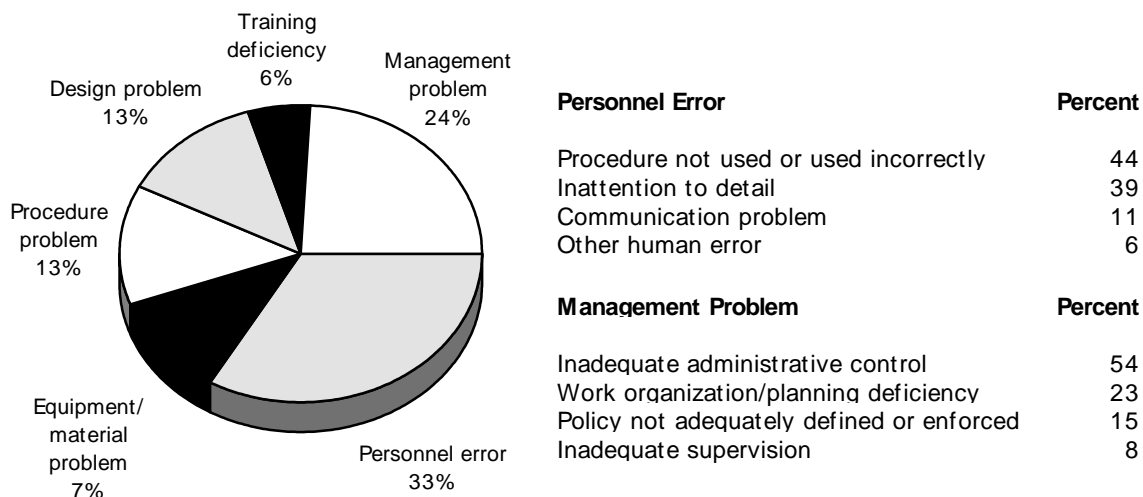
**Figure 3-1. Distribution of Root Causes for Inadvertent Transfer of Solutions<sup>1</sup>**

Operating Experience Analysis and Feedback (OEAF) engineers reviewed the Occurrence Reporting and Processing System (ORPS) database for reports involving inadvertent transfers of solutions and found 55 occurrences. Figure 3-1 shows the distribution of root causes reported by facility managers for these events. Personnel error represented 33 percent of the root causes and management problem, 24 percent. Procedure not used or used incorrectly accounted for 44 percent of the personnel errors, and inadequate administrative control accounted for 54 percent of the management problems.

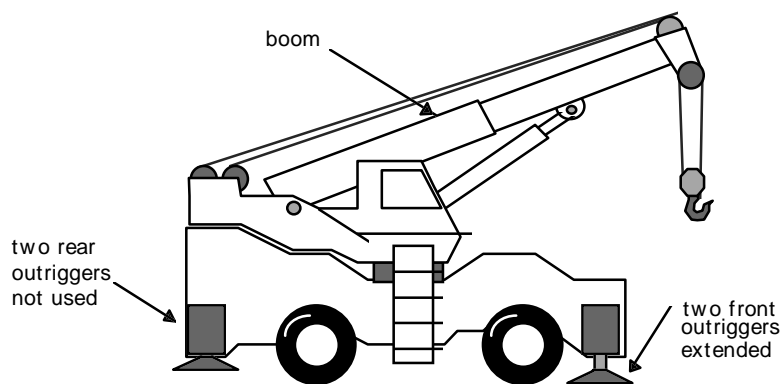
**Figure 4-1. Typical Hydraulic Crane**

On May 30, 1997, at the Hanford Tank Farms, a 30-ton mobile, hydraulic crane lifting a 4,600-pound steel trench box tipped, and the boom landed on a 10-foot mound of dirt. The crane came to rest against the mound at a 45-degree angle. The crane operator and an assisting flagman were not injured. Investigators determined that the crane operator failed to extend all four outriggers as required for this type of lift. Loss of control of the crane could have caused equipment damage or personnel injury. (RL--PHMC-TANKFARM-1997-0048)

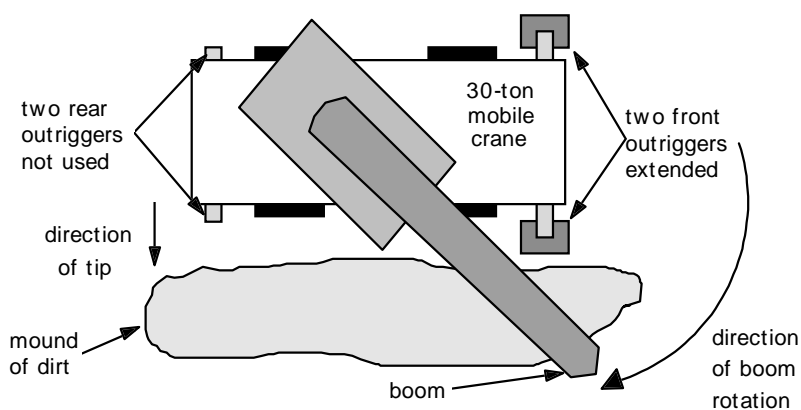
**Figure 4-2. Top View of the Hydraulic Crane Showing the Direction of Tip**

A subcontractor had excavated a trench and shored it with the steel trench box sections while installing a new underground transfer line. When the excavators were finished installing the line, the crane operator used the crane to pick up the trench boxes and stack them for removal. Investigators determined that the operator extended the front two outriggers of the crane, but failed to extend the rear two, when preparing to lift the sections. A typical hydraulic crane, displaying the outrigger configuration, is shown in figure 4-1. The operator picked up the load and extended the boom. As he rotated the load to the side of the crane, the crane fell against the mound of dirt (see figure 4-2). The operator shut down the crane and exited without injury.

Investigators determined that the load rating chart for the crane permitted lifts without extended outriggers. However, the allowable load, boom angle, and extension are greatly reduced. The load chart does not address operating the crane with only two outriggers extended. According to the load chart, the capacity and geometry of the lift were acceptable with all outriggers extended. Investigators determined that the crane operator failed to properly configure the crane for the lift.

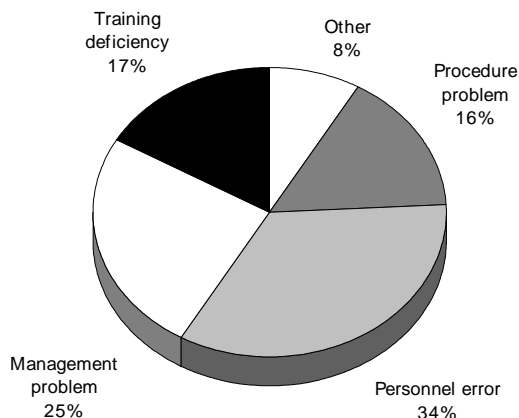
**Figure 5-1. Distribution of Contributing Causes for Loss of Control of Radioactive Material Procedure Violations<sup>1</sup>**

Operating Experience Analysis and Feedback (OEAF) engineers reviewed the ORPS database for procedures not used or used incorrectly and for loss of control of radioactive material and found 108 occurrences. Figure 5-1 shows the contributing causes for these events across the DOE complex. Personnel error represented 34 percent of the contributing causes, with 54 percent of personnel error attributed to inattention to detail. Management problems represented 25 percent of the contributing causes, with 37 percent of management problems attributed to inadequate administrative control and supervision and 30 percent attributed to policy not adequately defined, disseminated, or enforced.
